HD Technologies Case Study: Press roll bearing damage detection

Paper Machine K25,
Vrancart SA, Romania

SPM Instrument Bulgaria EOOD

August 2018

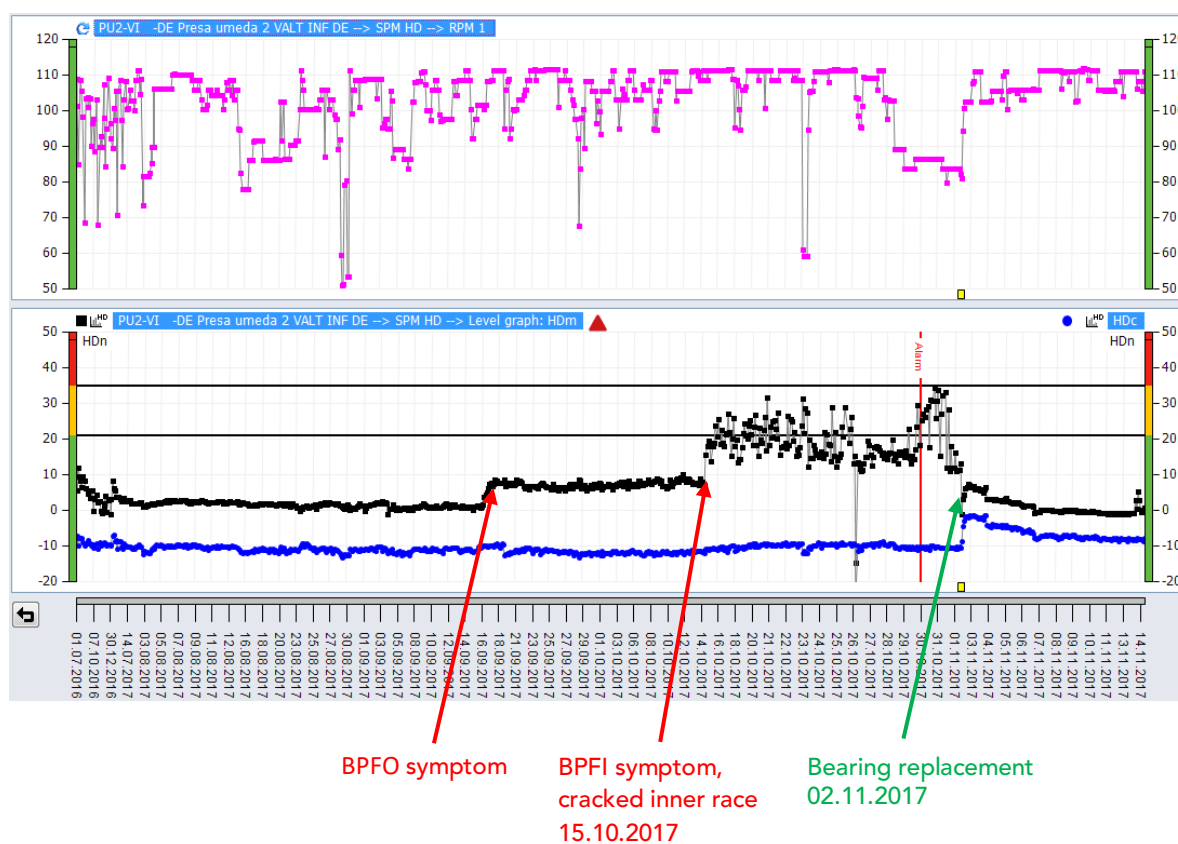
From September 17, 2017, a small but stable increase in the shock pulse levels (HDm/HDc = 8 / -12 dB) was noticed.

On October 16, 2017, there was a second, more rapid increase and levels raised to HDm/HDc = 27/-11 dB. At the same time, in addition to the BPFO symptom, frequencies matching the BPFIM bearing symptom also appeared in the SPM HD Spectrum.

On October 30, 2017, the shock pulse levels reached HDm/HDc = 45/-11 dB, while the vibration levels remained low.

Figure 2. SPM HD trend graph HDm/HDC, from August 2016 to November 2017.

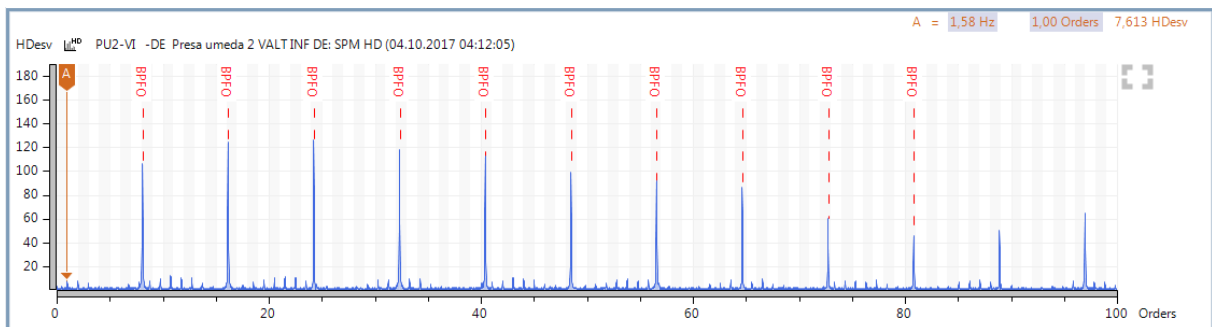
From the beginning of the measurements on the press roll, starting on July 1st, 2016 until September 17th, 2017 there were visible frequencies in the SPM HD Spectrum matching the BPFO bearing symptom. The amplitude, however, was low: HDm/HDc = 1 / -10 dB.

Figure 4. SPM HD Spectrum before inner race crack - Press №2, lower roll bearing DS, BPFO symptom.

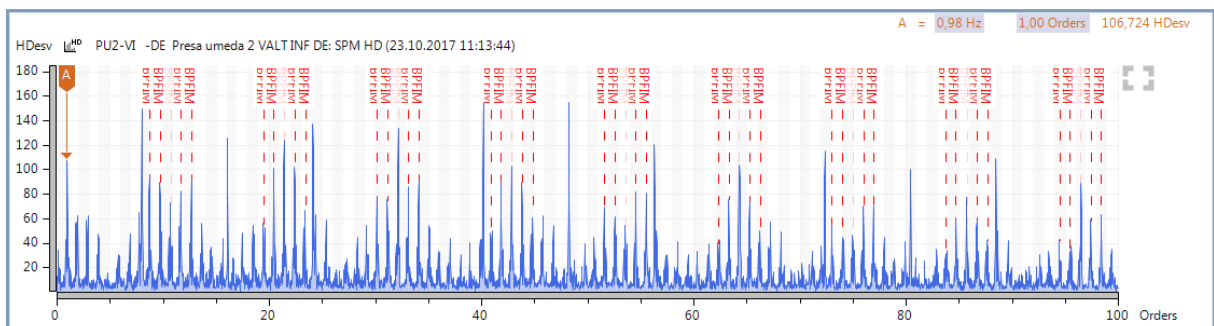
Figure 5. SPM HD Spectrum after inner race crack - Press №2, lower roll bearing DS, showing BPFO and BPFIM symptoms.

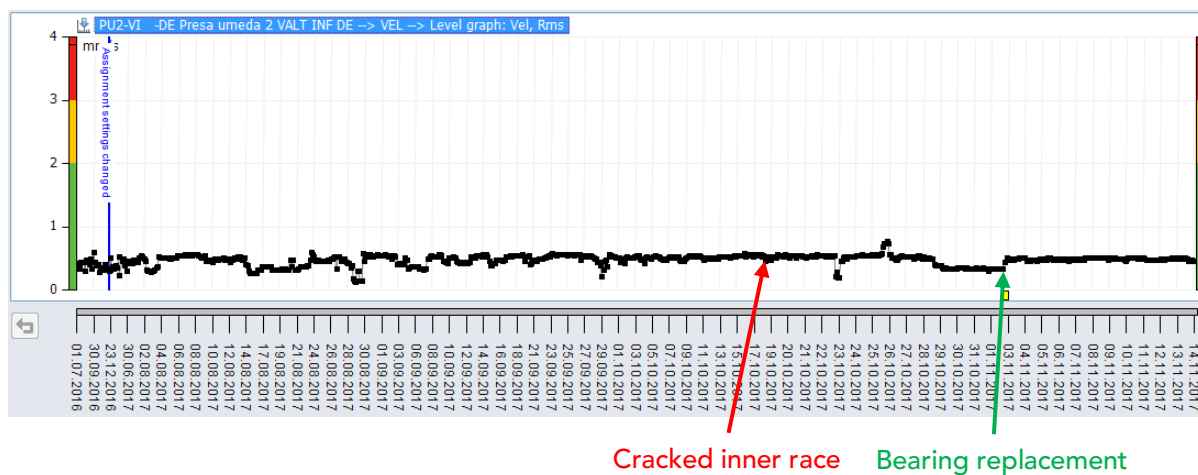
During the specified time, vibration levels did not rise at all, and the vibration spectrum did not show any signs of bearing damage. As can be seen in Fig. 22, the RMS levels did not show much, but with HD ENV quite good results were achieved. When comparing readings with the different measuring technologies, it can be seen that SPM HD and HD ENV Filter 4 showed very similar results.

Figure 22. Velocity - VEL trend graph, from August 2016 to November 2017.

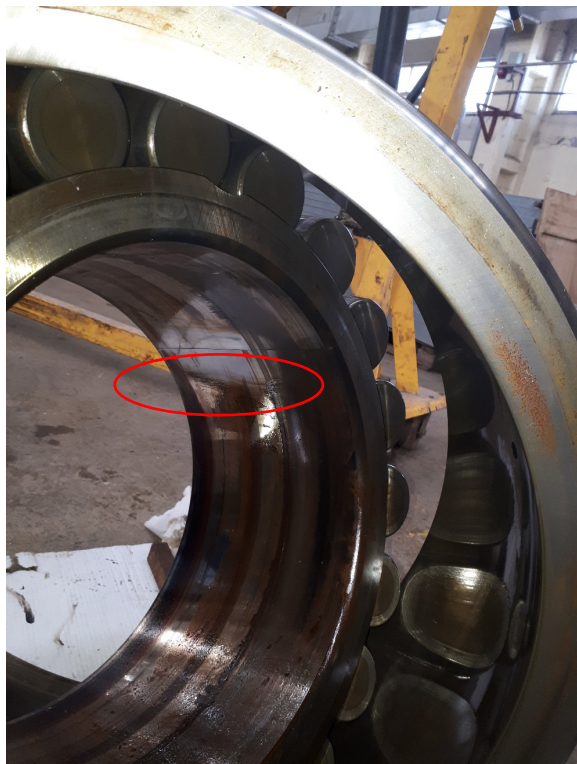
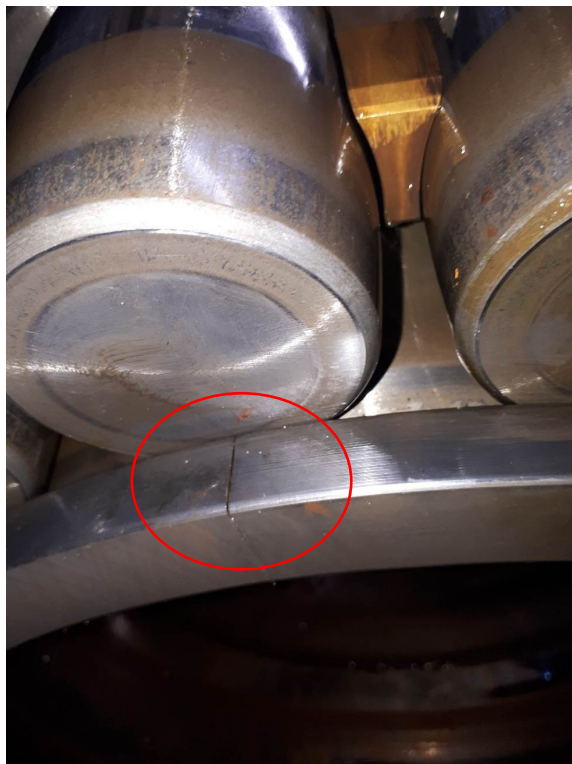
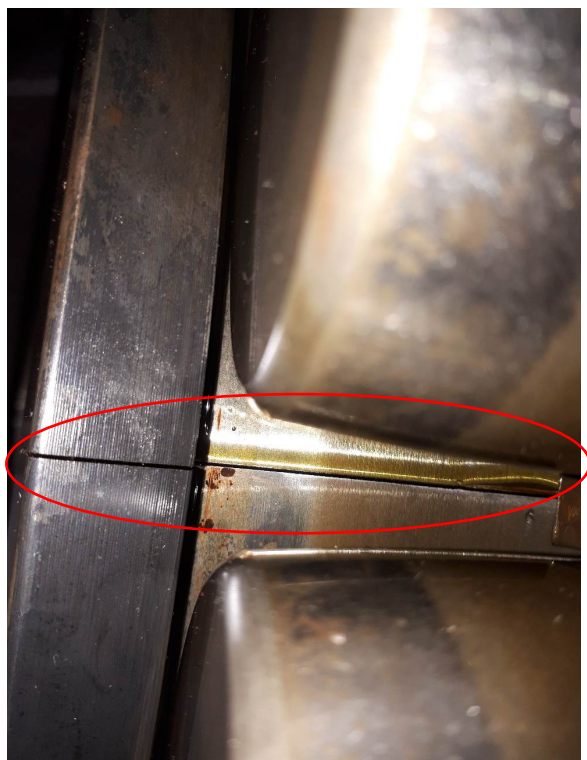
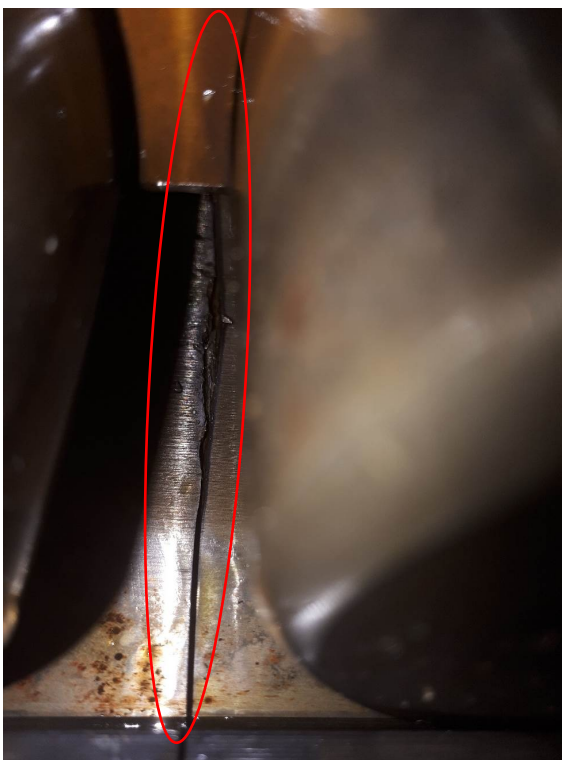
On November 2nd, 2017, the paper machine was stopped for investigation, and the bearing was replaced due to a visible crack on the inner race.

The cause of this bearing failure was most probably the extra high load on the press.

Image 2. Cracked inner race.

Image 3. Cracked inner race.

Image 4. Cracked inner race.

Image 5. Cracked inner race.

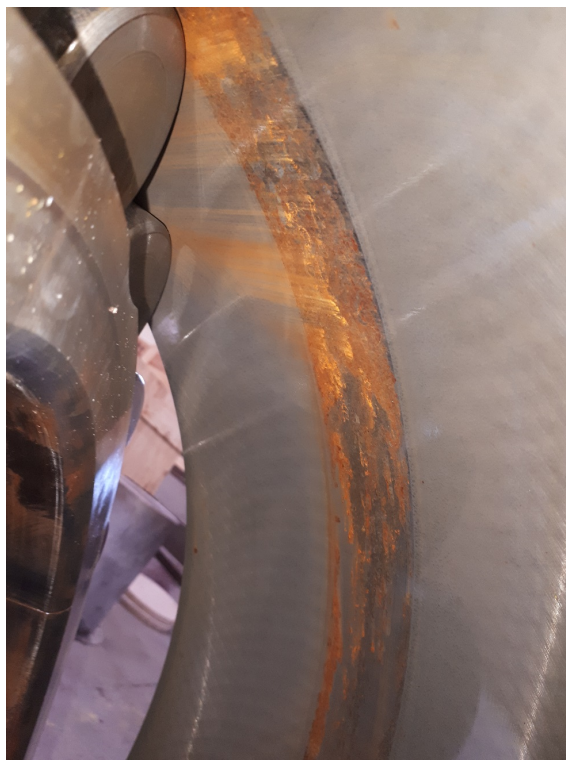
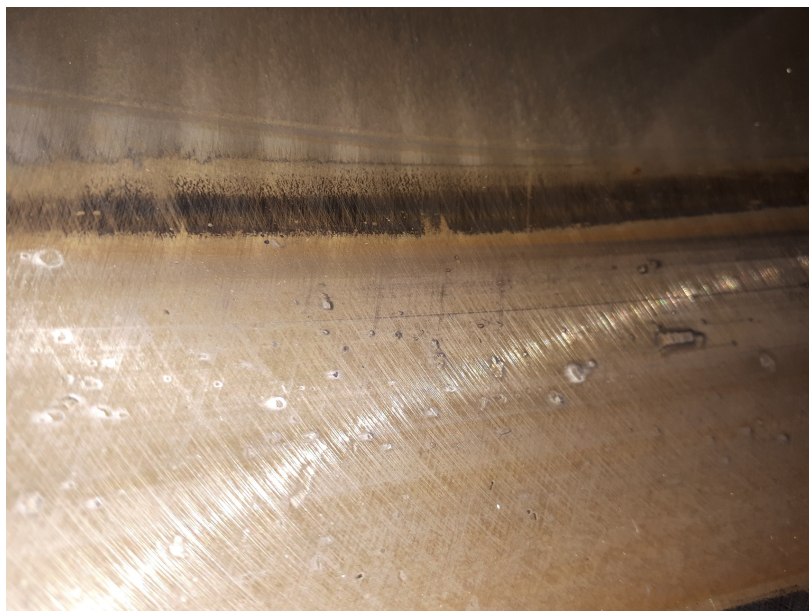
On the bearing outer race, there were visible traces of rust and small spots which could be the source of the BPFO symptom before the inner race crack. The bearing was under warranty, and the client called the bearing manufacturer for revision and investigation of the cause of the failure.

Image 6. Outer race.

Image 7. Outer race.
