Evidence of fire resistance of hollow-core slabs

K.D. Hertz, Professor Dept. of Civil Engineering, Technical University of Denmark.L.S.Sørensen, Associate Professor Danish Building Research Institute, Aalborg University.L.Giuliani, Associate Professor Dept. of Civil Engineering, Technical University of Denmark.

Fire Safety Day 2015 Evidence of fire resistance of hollow-core slabs

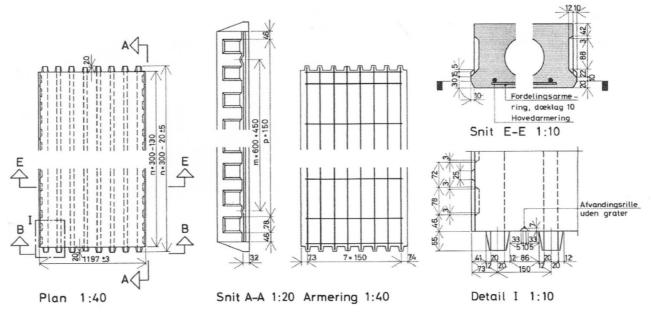
Figure 1. The classic hollow-core slabs with slack reinforcement and transverse reinforcement of the bottom flange [1].

The original classic hollow-core slabs were 0.6 m or 1.2 m wide slabs with holes made by means of mandrels pressed into the concrete from both ends of the element. These classic hollow-core slabs were dominant for the first 30-40 years. The geometry and reinforcement of them are seen on Figure 1. They had slack deformed bars as main reinforcement in the longitudinal direction and a mesh of mild steel was placed in the bottom. This means that the bottom flange under the holes was reinforced across the element, keeping the bottom flange in place.

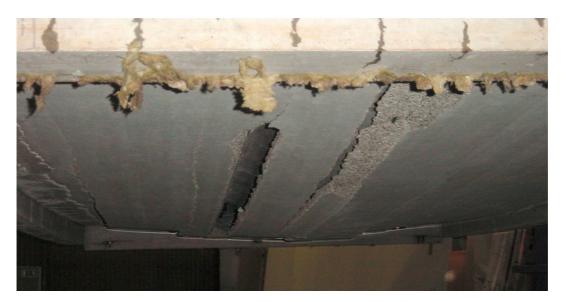
Figure 2. Damages after 25 minutes standard fire on two extruded hollow-core slabs with cast groove between and cast into a reinforced frame. Test from 2004 (H138 in [2]). Photo K. Hertz.

However, the slab elements were the new extruded version with no cross reinforcement, and the test result was about 25 minutes. The result caused a debate on the fire resistance of hollow-core slabs in Denmark. The debate resulted in a further test in 2004, where the fire resistance time was again found to be 25 minutes. As seen in Figure 2 the bottom flange of the slab fell down and large cracks were developed to the other channels.

However, tests and similar observations from actual fires (authors experience) show that the integrity of the bottom flange is a problem especially for the new extruded versions of the hollow-core slab without cross reinforcement in the bottom flange, because big cracks appear along the deck under the channels and often the bottom flange even falls down as for example shown in Figure 2 and 3.

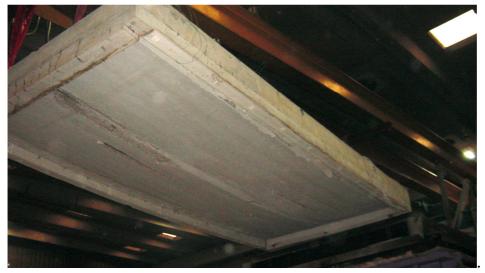
Figure 3. Test H138 in [2]. Hollow-core slab after 25 min. Photo K. Hertz.

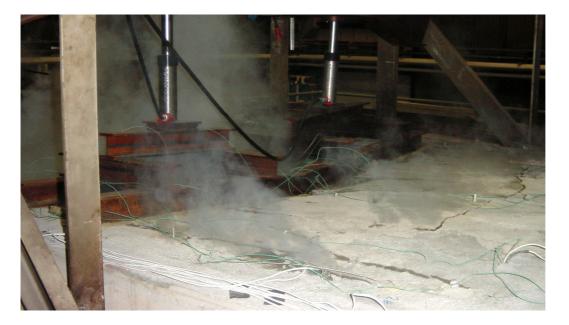
Figure 4. Test H138 in [2]. Cracks in top flange after approx. 15 min. Photo K. Hertz.

From the tests we see that the cracks in the bottom flange must be considered as serious after 10-15 minutes, where we also observe cracks in the top flange (Figure 4). The Holcofire report [2] states more precisely that the cracks in the bottom flange are formed after 6 minutes.
