MIXING PUMP

Wireless sensor Airius LTE-M detects bearing failure

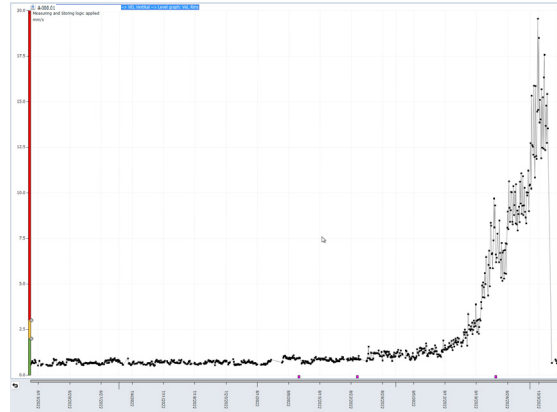
The velocity measurement trend started to rise in mid-September 2022.

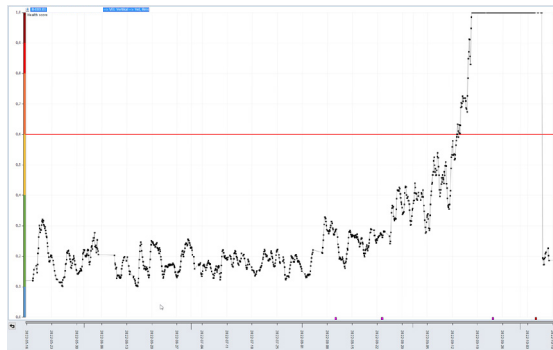
The Health score shows a sharply rising trend before the bearing replacement.

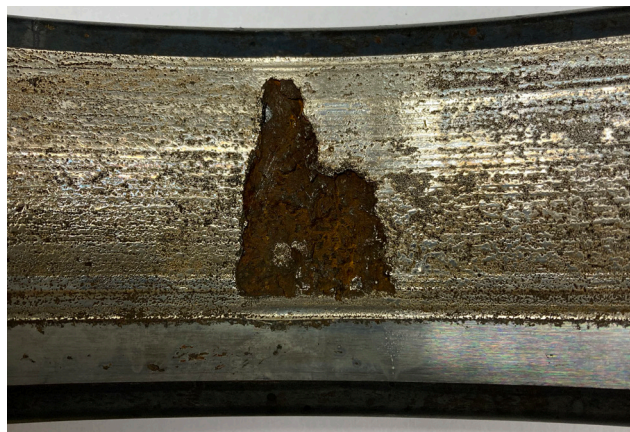
The outer race damage that was revealed upon bearing replacement.

During the proof-of-concept period, bearing damage was found in the mixing pump in one of the mill's paper machines. Increasing acceleration levels alerted the maintenance department of a budding problem and justified monitoring the development more closely. Over the following two months, speed vibration and health score trends also increased. About three months after the first signs of damage, the maintenance personnel stopped the pump and replaced the bearing.

The vibration measurements with the Airius sensor allowed the mill to detect and follow the course of damage in this A-rated pump, thus enabling the planning of the bearing replacement to be carried out during a planned maintenance stop.
